TUDELU, LLC ACOUSTICAL PERFORMANCE TEST REPORT

ASTM E90 SOUND TRANSMISSION LOSS TESTING ON
TUDELU PRIVATE, ACOUSTICAL PANELS

P3024.04-113-11-R1

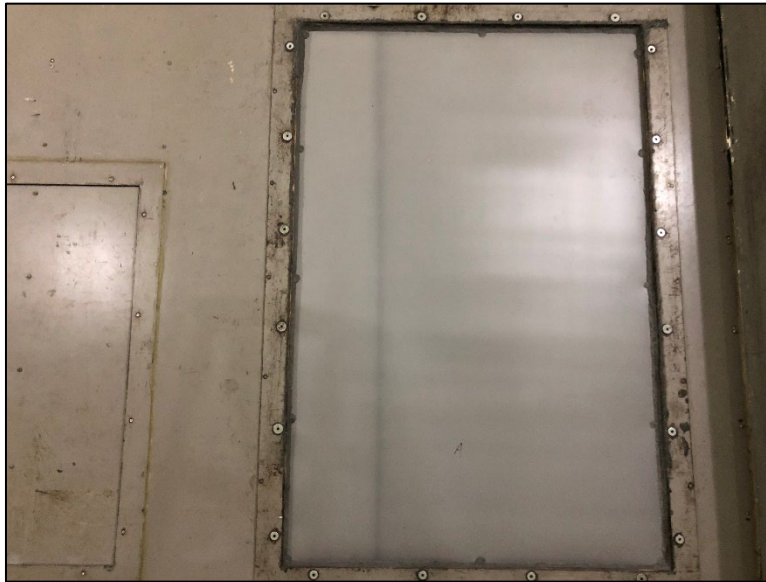
Photo No. 1

Receive Room View of Installed Test Specimen

Tudelu Private acoustical panels consisted of one 48" by 72" frame constructed with 1-1/2" thick by 4" wide wood lumber and fastened together with screws. One layer of mass loaded vinyl was screwed to the wood frame on both sides, creating the 4" air space.

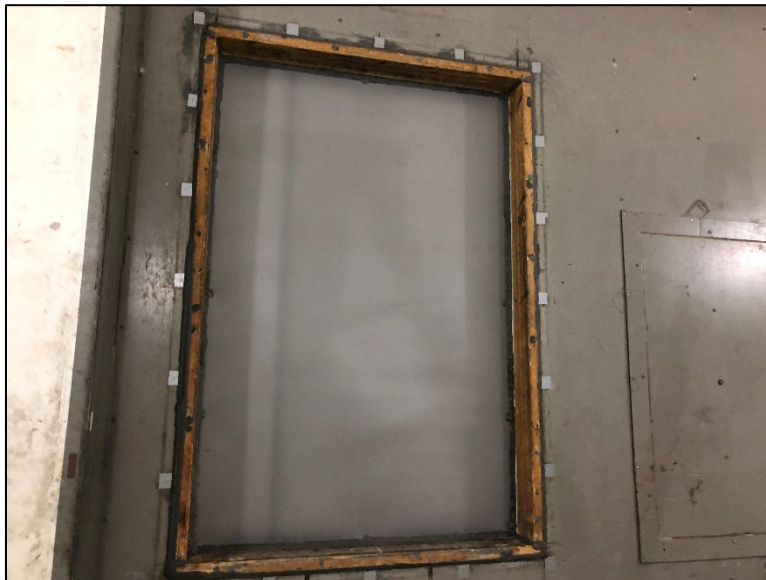
Photo No. 2

Source Room View of Installed Test Specimen
