# TUDELU, LLC ACOUSTICAL PERFORMANCE TEST REPORT

ASTM E90 SOUND TRANSMISSION LOSS TESTING ON  
TUDELU PRIVATE, ACOUSTICAL PANELS

P3024.05-113-11-R0

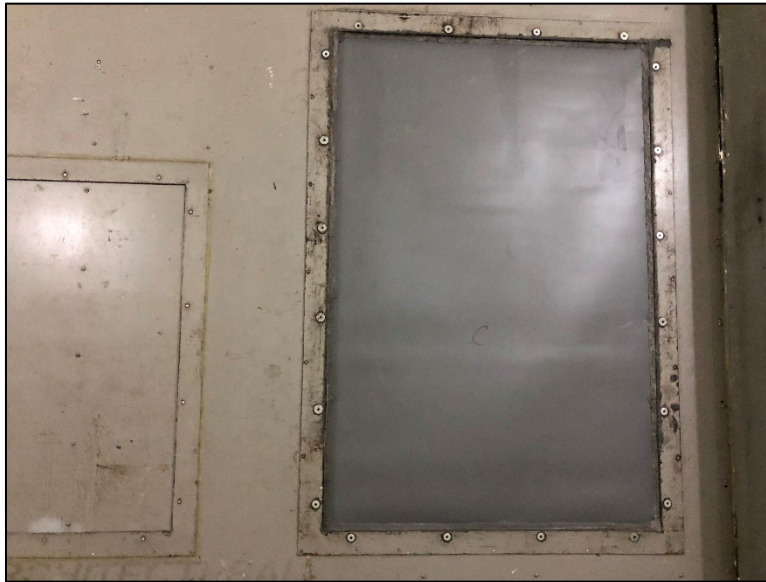
**Photo No. 1**  
**Receive Room View of Installed Test Specimen**

Tudelu Private acoustical panels consisted of one 48" by 72" frame constructed with 1-1/2" thick by 4" wide wood lumber and fastened together with screws. One layer of mass loaded vinyl was screwed to the wood frame on both sides, creating the 4" air space. The backing material faced inward towards the 4" air space.
